SUBJECT: **REPORT OF CONDITION ASSESSMENT & CAPITAL RESERVE STUDY 2005**  
Central Park Recreational Facility  
Canton, Michigan  
Synergy ENG Project No. 04.1057

Synergy ENG has completed a report of our Condition Assessment and Capital Reserve Study for the Central Park Recreational Facility located in Canton, Michigan.

On September 24, 2004, Benjamin Dutton, R.S. of Synergy ENG visited the community to quantify and assess the condition of the community common elements. The survey was visual in nature, and involved no destruction to gain access to hidden conditions. Mr. Ibu El, the Association Treasurer, assisted Synergy ENG on site and provided additional information.

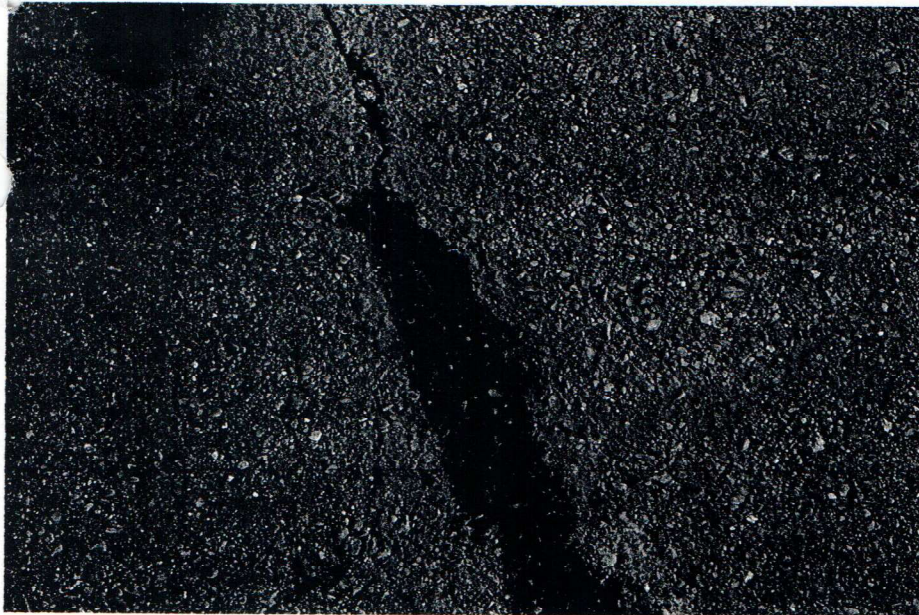
**PHOTO #1**

The asphalt-paved parking lot is generally in good condition. However, we noted localized areas of pavement cracks (reference Photograph 1 in Appendix E) and faded surface markings, localized areas of rutting and surface damage (reference

**Crack at asphalt-paved parking lot. Cracks should be filled near-term and periodically to reduce water infiltration into and subsequent damage to the pavement subbase ("foundation")**

- 1.1 - We recommend crack filling, seal coating and re-stripping the asphalt-paved parking lot every five years from 2005, except when pavements are resurfaced. Our opinion of cost for each cycle of crack filling, seal coating and re-stripping is \$2,325. This cost assumes the application of a two-coat

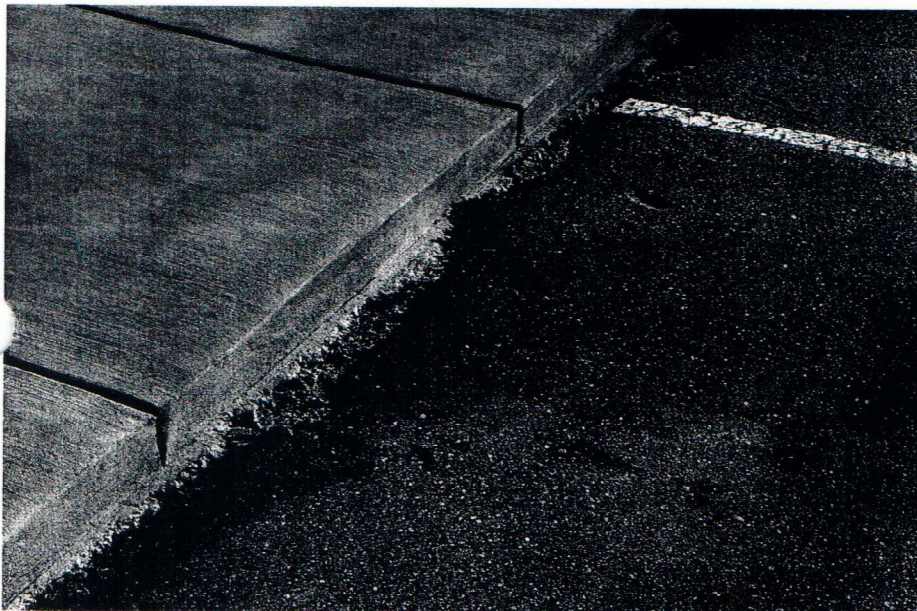
**PHOTO #2**

**Damage at asphalt-paved parking lot. We have recommended that an allowance be made for the periodic coating and repair of the pavements, followed by late-term replacement**

1.2 - We recommend that an escalating allowance be made for the removal and replacement of areas of settled pavement, rutting and alligator cracking. Our opinion of cost includes for removal of failed asphalt to the stone subbase course and installing new asphalt and stone as necessary. Cost assumes that this work is completed every five years from 2010 in conjunction with seal coating and resurfacing cycles. Reference Maintenance Protocol 3 in Section 4.

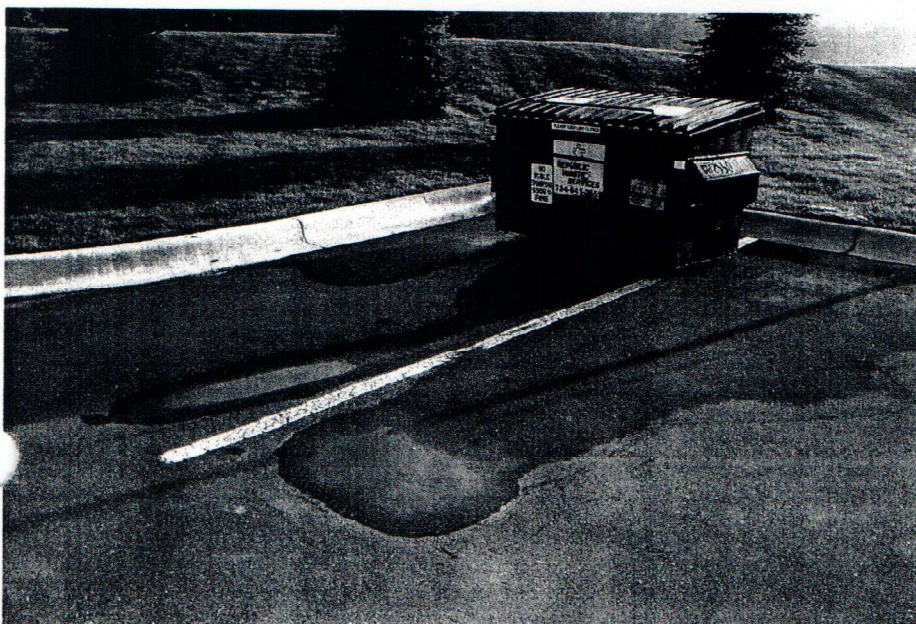
**PHOTO #3**

Overloading of the pavement was contained to the location where the dumpster unit was placed directly on the pavement surface. Our experience with similar communities and our observation of present site conditions indicates that if the dumpster unit is allowed to remain on the pavement surface advanced deterioration of adjacent pavement areas will take place. Therefore, we recommend that the community budget an allowance of approximately \$1,600 for the installation of a 5" thick welded-wire-mesh reinforced concrete slab at this area. As a newly installed component and not a replacement project, this cost is not included within this reserve fund plan.

**Dumpster unit placed directly on asphalt pavement resulting in overloading of the pavement section. We recommend that the Association consider the installation of a cast-in-place concrete pad below and surrounding the dumpster unit**

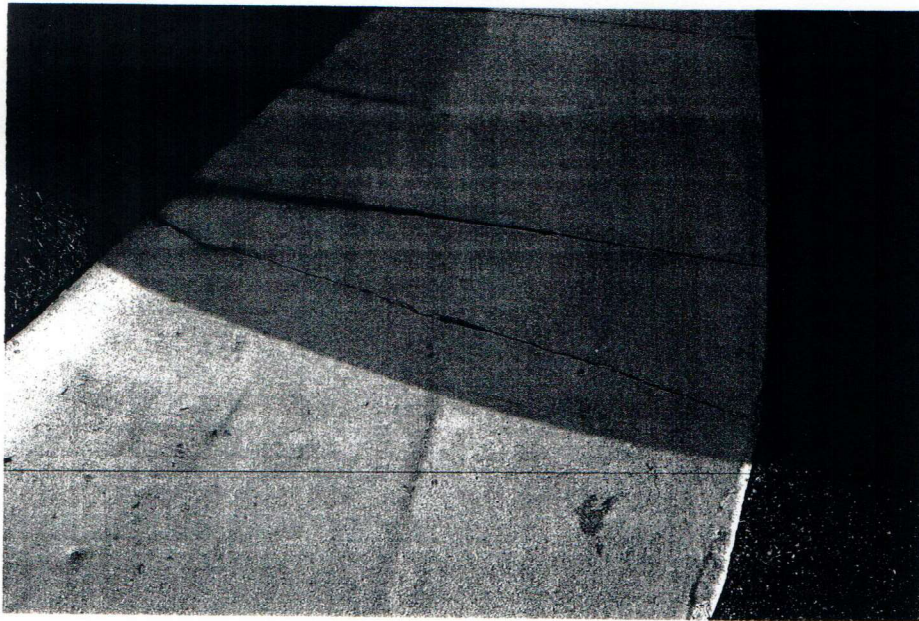
Concrete sidewalks are generally in fair to good condition. However, we noted six cracked sidewalk sections (reference Photograph 4 in Appendix E). We have recommend budgeting an on-going yearly allowance for the replacement of cracked, settled, spalled or otherwise deteriorated concrete sidewalks throughout the study period.

**PHOTO #4**  
Cracked sidewalk panel. We have recommended that an allowance be made for the on-going replacement of cracked, settled and spalled site concrete

1.4 - The reserve tables include a variable allowance to replace cracked, settled and spalled concrete sidewalks every year starting in 2005. Reference Maintenance Protocol 5 in Section 4.

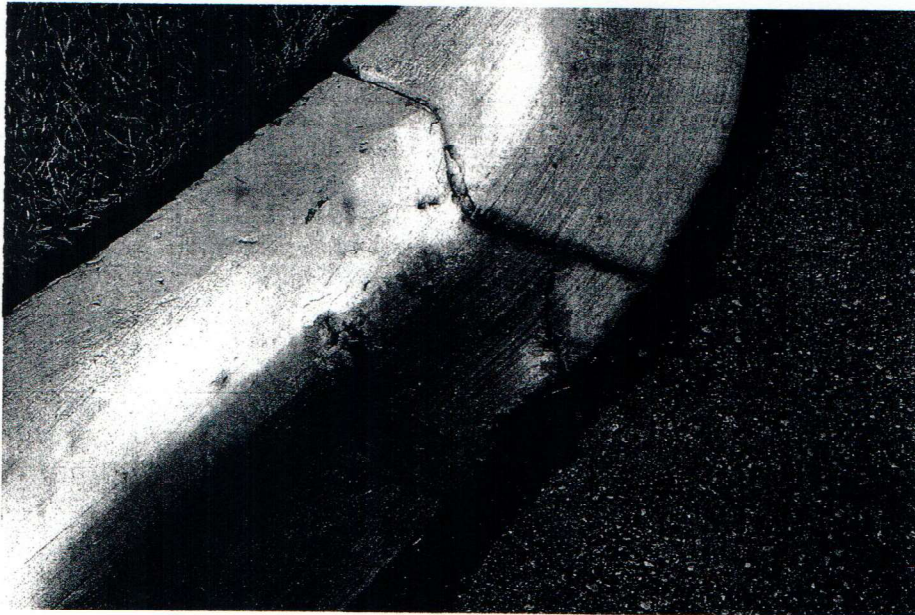
Concrete curb and gutter sections are generally in good condition. However, we noted ten cracked curb section, one settled section and four spalled sections (reference Photograph 5 in Appendix E). Similar to the approach adopted for sidewalk replacement, we recommend that a yearly allowance be made for replacement of deteriorated curb and gutter sections.

**PHOTO #5**  
Cracked curb and gutter section. We have recommended that an allowance be made for the on-going replacement of cracked, settled and spalled site concrete

1.5 - The reserve tables include a variable allowance to replace cracked, settled and spalled concrete curb and gutter sections every year starting in 2005. Reference Maintenance Protocol 6 in Section 4.

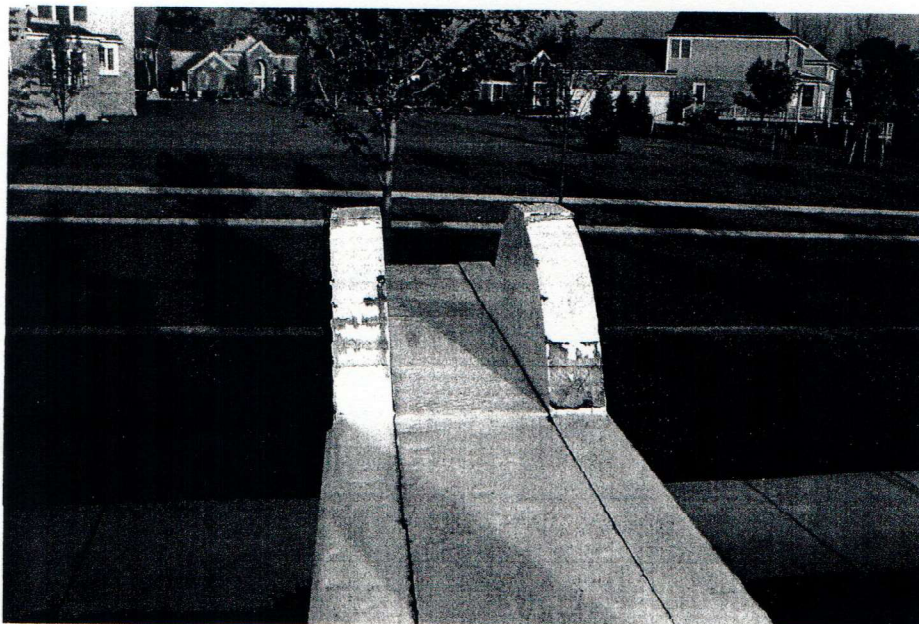
Site and entrance signs are generally in good condition. However, we noted localized corrosion at signposts, and noted peeled paint and deteriorated wood sections at the entrance sign panels (reference Photograph 6 in Appendix E). Assuming the cleaning, priming and repainting of signposts, and the repainting of entrance sign panels near-term as an operating expense, replacement of signs is not anticipated until mid-term.

**PHOTO #6**  
Peeled paint and localized deterioration at entrance signage. We recommend that the Association complete periodic cleaning and painting of the entrance signs as an operating expense, followed by mid-term replacement

1.7 - The reserve fund tables include an allowance of \$1,500 for the replacement of entrance signs in 2014. This replacement cost and schedule assumes replacement with high-density urethane (HDU) sign panels. HDU signs maintain the same appearance as wood signs but require less maintenance and typically last in excess of 15-years. Reference Maintenance Protocol 8 in Section 4.

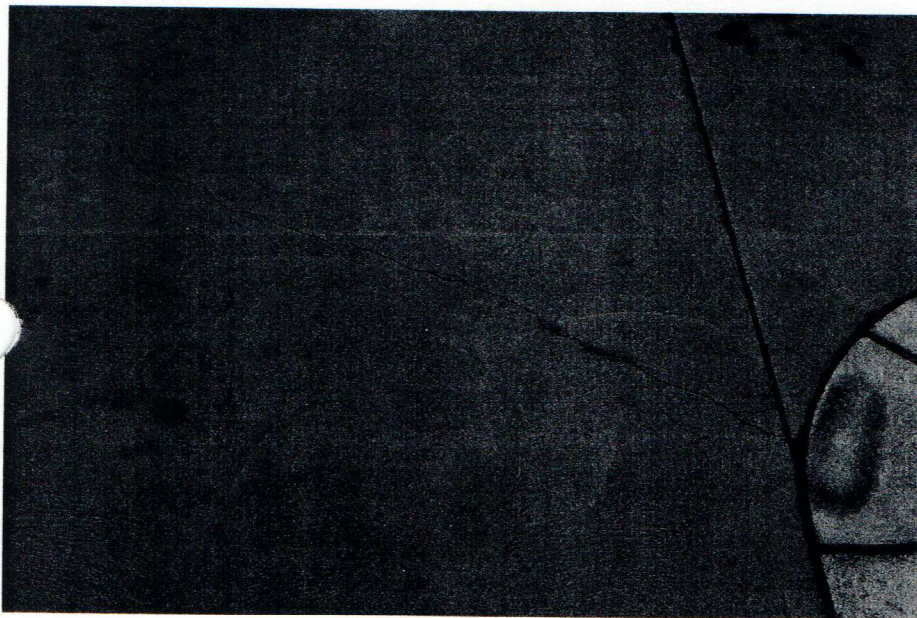
The pool deck is in generally good condition. However, we noted instances of longitudinal and traverse concrete cracks (reference Photograph 8 in Appendix E). We have recommended that an allowance be made for the cyclical replacement of the pool deck throughout the study period, followed by full replacement in conjunction with the pool restoration project.

**PHOTO #8**  
Cracked concrete at pool deck. Periodic cyclical replacement of the deck is recommended throughout the study period, followed by full replacement of the deck in conjunction with the recommended pool restoration project

- 2.8 - The reserve fund tables include an escalating allowance for the cyclical replacement of the pool deck every five years from 2010, with full replacement of the deck scheduled to coincide with the pool restoration project. Reference Maintenance Protocol 18 in Section 4.

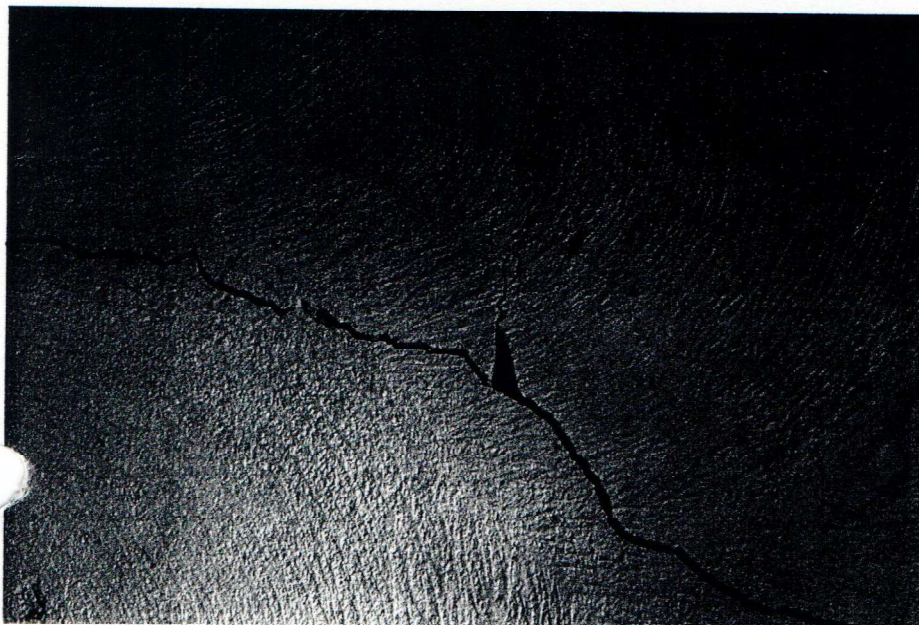
The slab-on-grade concrete provided at unenclosed portions of the building is in fair to good condition. We noted approximately 780 square feet of severely cracked and heaved concrete (reference Photograph 9 in Appendix E). We recommend that the community rout and seal cracks near-term followed by replacement of the cracked and heaved concrete within the next two years.

**PHOTO #9**  
Cracked and heaved concrete at slab-on-grade. We recommend routing and sealing the slab near-term, followed by replacement
