SUBJECT: **REPORT OF CONDITION ASSESSMENT & CAPITAL RESERVE STUDY 2005**  
Central Park Recreational Facility  
Canton, Michigan  
Synergy ENG Project No. 04.1057

Synergy ENG has completed a report of our Condition Assessment and Capital Reserve Study for the Central Park Recreational Facility located in Canton, Michigan.

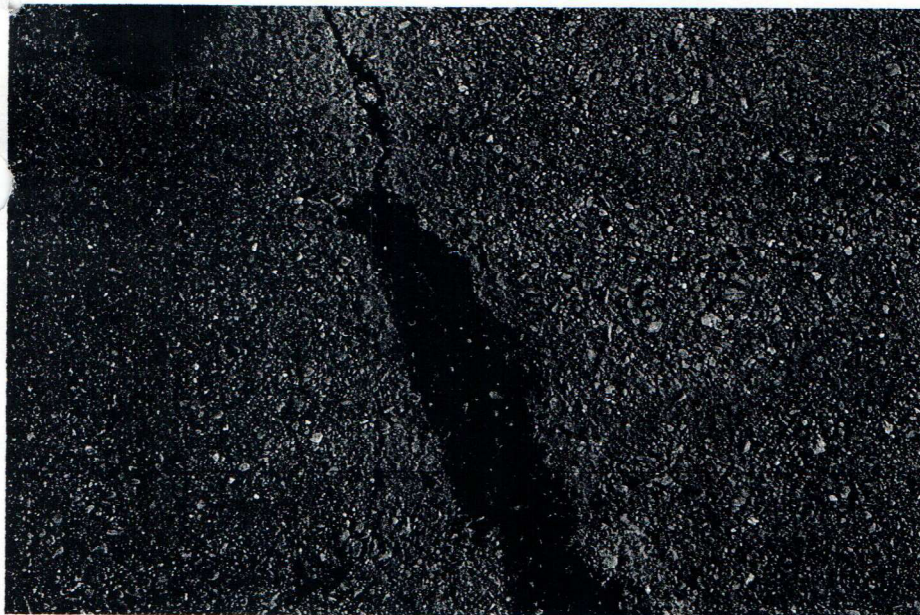
**PHOTO #1**

The asphalt-paved parking lot is generally in good condition. However, we noted localized areas of pavement cracks (reference Photograph 1 in Appendix E) and faded surface markings, localized areas of rutting and surface damage (reference

Crack at asphalt-paved parking lot. Cracks should be filled near-term and periodically to reduce water infiltration into and subsequent damage to the pavement subbase ("foundation")

- 1.1 - We recommend crack filling, seal coating and re-striping the asphalt-paved parking lot every five years from 2005, except when pavements are resurfaced. Our opinion of cost for each cycle of crack filling, seal coating and re-striping is \$2,325. This cost assumes the application of a two-coat

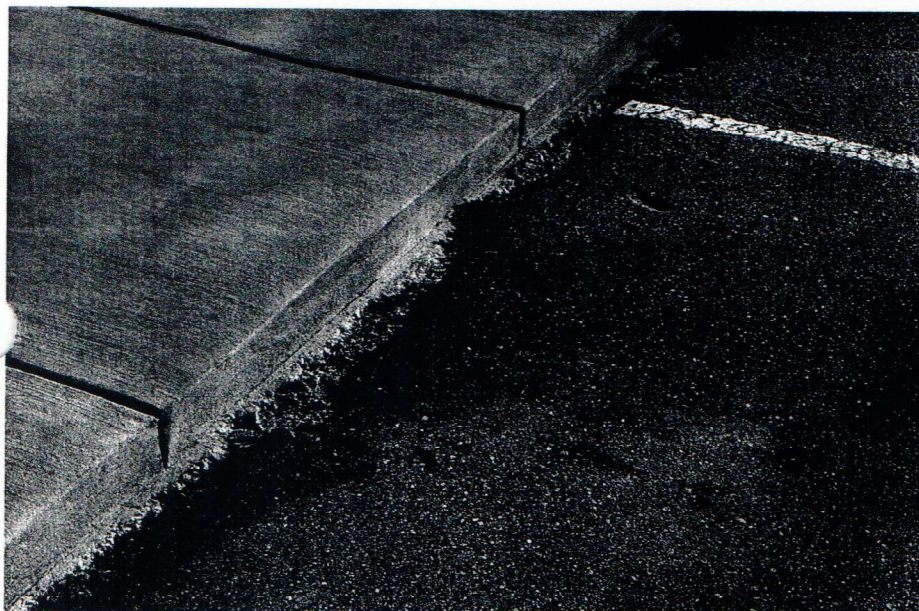
**PHOTO #2**

Damage at asphalt-paved parking lot. We have recommended that an allowance be made for the periodic coating and repair of the pavements, followed by late-term replacement

- 1.2 - We recommend that an escalating allowance be made for the removal and replacement of areas of settled pavement, rutting and alligator cracking. Our opinion of cost includes for removal of failed asphalt to the stone subbase course and installing new asphalt and stone as necessary. Cost assumes that this work is completed every five years from 2010 in conjunction with seal coating and resurfacing cycles. Reference Maintenance Protocol 3 in Section 4.

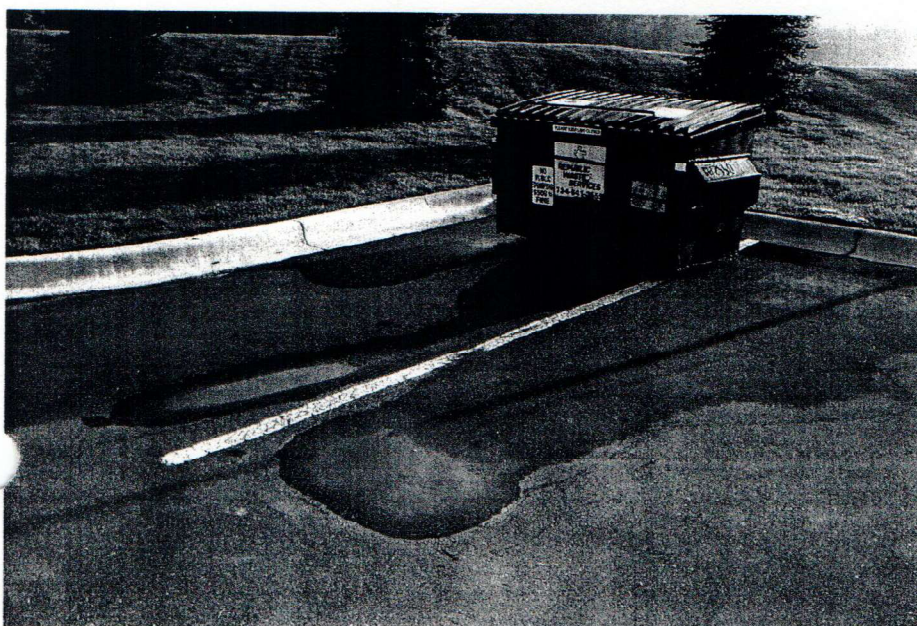
**PHOTO #3**

Overloading of the pavement was contained to the location where the dumpster unit was placed directly on the pavement surface. Our experience with similar communities and our observation of present site conditions indicates that if the dumpster unit is allowed to remain on the pavement surface advanced deterioration of adjacent pavement areas will take place. Therefore, we recommend that the community budget an allowance of approximately \$1,600 for the installation of a 5" thick welded-wire-mesh reinforced concrete slab at this area. As a newly installed component and not a replacement project, this cost is not included within this reserve fund plan.

Dumpster unit placed directly on asphalt pavement resulting in overloading of the pavement section. We recommend that the Association consider the installation of a cast-in-place concrete pad below and surrounding the dumpster unit

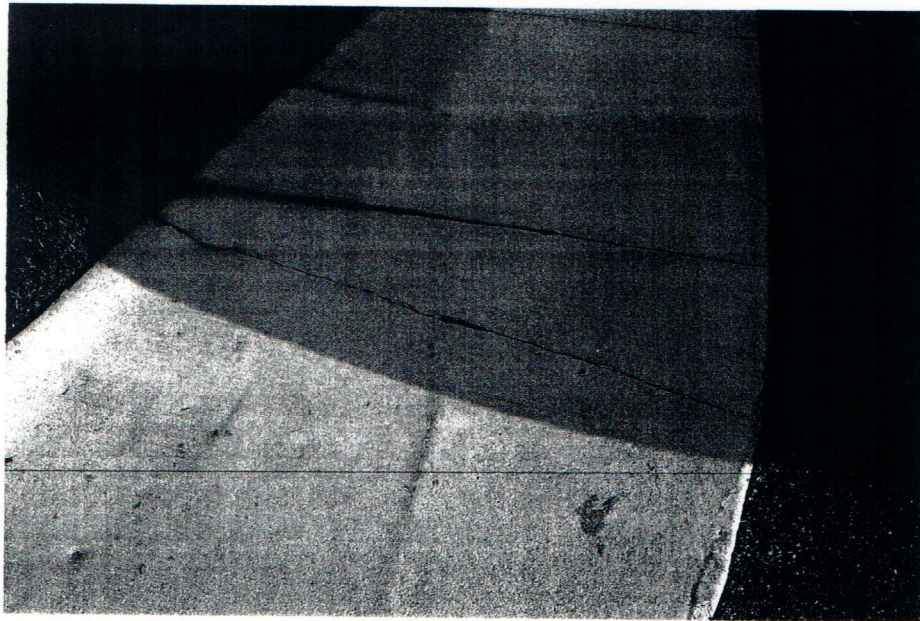
**PHOTO #4**

Concrete sidewalks are generally in fair to good condition. However, we noted six cracked sidewalk sections (reference Photograph 4 in Appendix E). We have recommend budgeting an on-going yearly allowance for the replacement of cracked, settled, spalled or otherwise deteriorated concrete sidewalks throughout the study period.

**Cracked sidewalk panel. We have recommended that an allowance be made for the on-going replacement of cracked, settled and spalled site concrete**

- 1.4 - The reserve tables include a variable allowance to replace cracked, settled and spalled concrete sidewalks every year starting in 2005. Reference Maintenance Protocol 5 in Section 4.

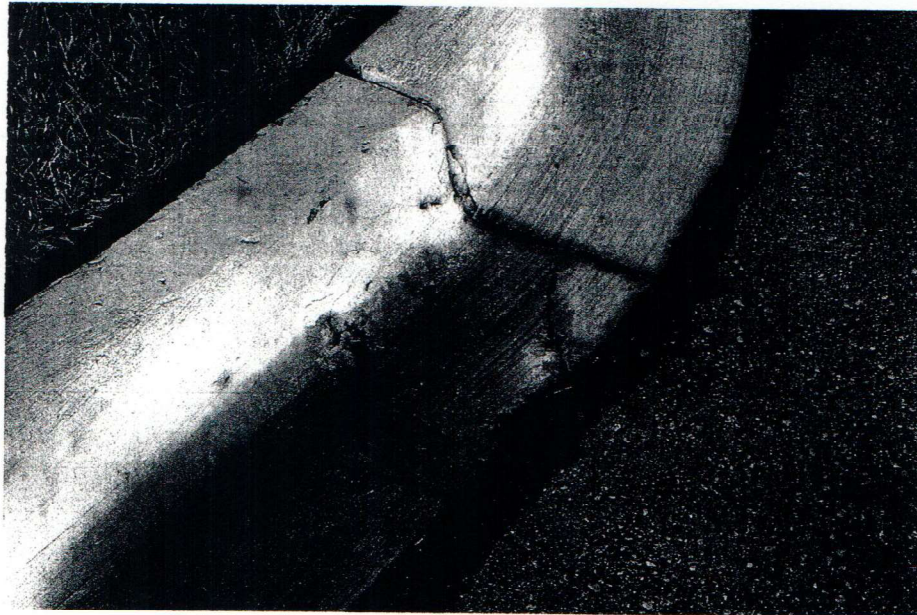
**PHOTO #5**

Concrete curb and gutter sections are generally in good condition. However, we noted ten cracked curb section, one settled section and four spalled sections (reference Photograph 5 in Appendix E). Similar to the approach adopted for sidewalk replacement, we recommend that a yearly allowance be made for replacement of deteriorated curb and gutter sections.

**Cracked curb and gutter section. We have recommended that an allowance be made for the on-going replacement of cracked, settled and spalled site concrete**

- 1.5 - The reserve tables include a variable allowance to replace cracked, settled and spalled concrete curb and gutter sections every year starting in 2005. Reference Maintenance Protocol 6 in Section 4.

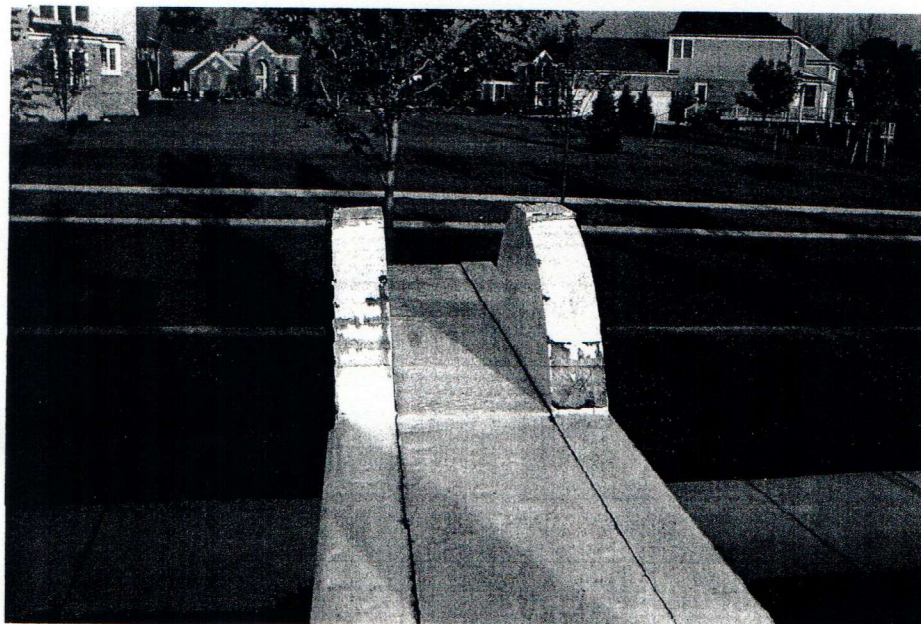
**PHOTO #6**

Site and entrance signs are generally in good condition. However, we noted localized corrosion at signposts, and noted peeled paint and deteriorated wood sections at the entrance sign panels (reference Photograph 6 in Appendix E). Assuming the cleaning, priming and repainting of signposts, and the repainting of entrance sign panels near-term as an operating expense, replacement of signs is not anticipated until mid-term.

**Peeled paint and localized deterioration at entrance signage. We recommend that the Association complete periodic cleaning and painting of the entrance signs as an operating expense, followed by mid-term replacement**

- 1.6 - We recommend that a sum of \$2,100 be budgeted for replacement of site signage in 2014. Reference Maintenance Protocol 7 in Section 4.
- 1.7 - The reserve fund tables include an allowance of \$1,500 for the replacement of entrance signs in 2014. This replacement cost and schedule assumes replacement with high-density urethane (HDU) sign panels. HDU signs maintain the same appearance as wood signs but require less maintenance and typically last in excess of 15-years. Reference Maintenance Protocol 8 in Section 4.

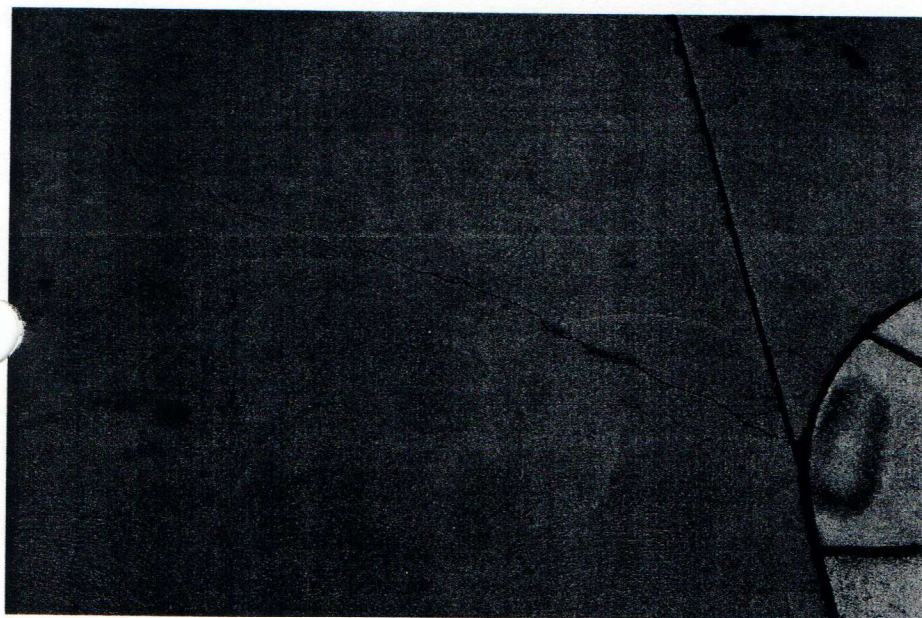
**PHOTO #8**

The pool deck is in generally good condition. However, we noted instances of longitudinal and traverse concrete cracks (reference Photograph 8 in Appendix E). We have recommended that an allowance be made for the cyclical replacement of the pool deck throughout the study period, followed by full replacement in conjunction with the pool restoration project.

Cracked concrete at pool deck. Periodic cyclical replacement of the deck is recommended throughout the study period, followed by full replacement of the deck in conjunction with the recommended pool restoration project

- 2.8 - The reserve fund tables include an escalating allowance for the cyclical replacement of the pool deck every five years from 2010, with full replacement of the deck scheduled to coincide with the pool restoration project. Reference Maintenance Protocol 18 in Section 4.

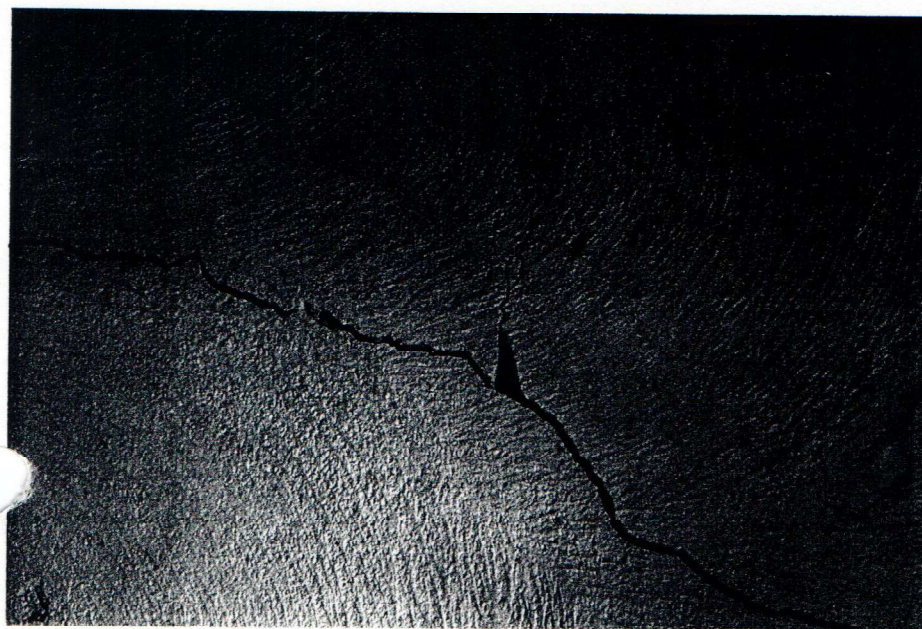
**PHOTO #9**

The slab-on-grade concrete provided at unenclosed portions of the building is in fair to good condition. We noted approximately 780 square feet of severely cracked and heaved concrete (reference Photograph 9 in Appendix E). We recommend that the community rout and seal cracks near-term followed by replacement of the cracked and heaved concrete within the next two years.

Cracked and heaved concrete at slab-on-grade. We recommend routing and sealing the slab near-term, followed by replacement
